## Hogcamp Branch Stream Stabilization Project

## Hogcamp Branch Stream Stabilization Project (continued...)

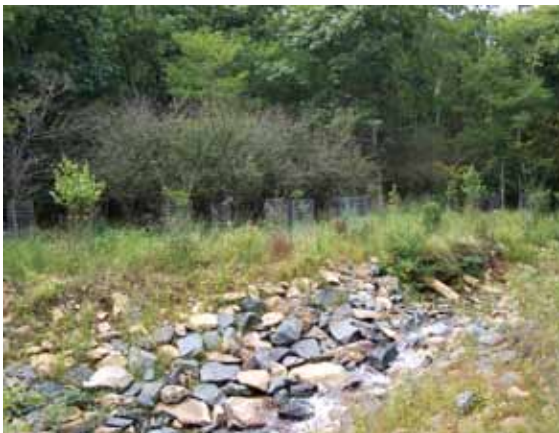
*Lower Sloping Drop Structure with re-vegetated bank areas (2004)*

**Observations-** The structures and rock armoring withstood all the heavy storms that occurred from 2002- 2004. There was less loss of periglacial slopewash substrate (from the banks and stream bottom) in recent years as opposed to 2001 and prior years (based on observations of bed scour and accumulation of trapped sediments). The rock checkdams trapped most of the sediments and gravel that would have normally escaped prior to 2002.

**Monitor and Repair Rock Structures-** Staff made minor repairs of the single- fence checkdams in the upper and lower sections. This consisted of crews bolstering the shoulders of the checkdams as well as adding rocks to the aprons of the checkdams. Staff made minor repairs to two loose- rock checkdams. This involved bolstering the downstream apron with large rocks to prevent undercutting. It also involved shoring up the “key” areas behind the checkdams with large rock to prevent further scouring from large rain events. This reduced the erodibility of the bed and lower banks. Staff also made minor repairs to the sloping drop structures after summer storms caused some minor rock shifting and bank scour to the lower drop structure and one downstream area. The “tightly nestled” rip rap helped the drop structures and rock armor withstand these storms. Photographs were taken in September 2004. Erosion control drainage dips were maintained along the old equipment route (horse trail).
